Beach Erosion Hazard Vulnerability Assessment of Bamburi Beach in Mombasa, Kenya

Index Terms—Beach erosion, beach vulnerability index, erosion vulnerability, beach profile.

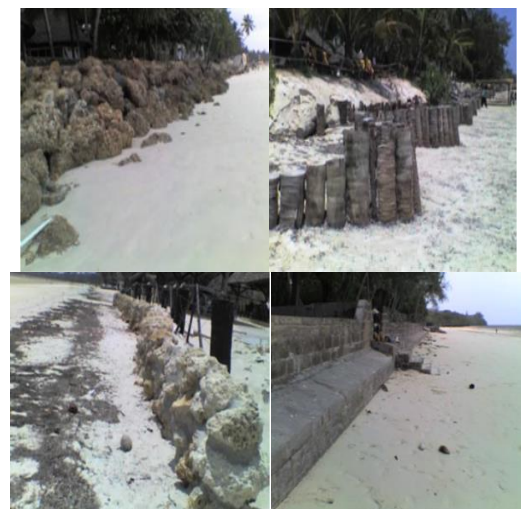
Fig. 1. Some photos showing shoreline protection measures at Bamburi beach.

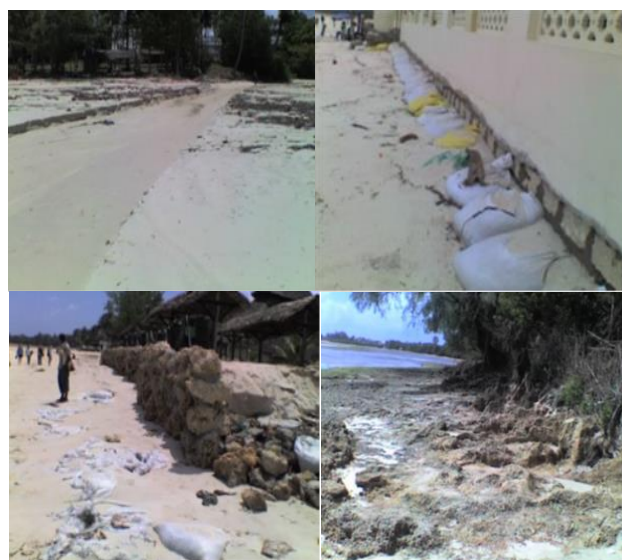
Fig. 3. Some of photos showing erosion activities at Bamburi beach.

The study was conducted within a period of one year from March 2013 to February 2014 along the Mombasa shoreline at Bamburi beach stretching for about 4 km long, on the Kenya coast. The study area is situated between latitudes $04^{\circ} 00' 30.5''$ South and $03^{\circ} 58' 55.9''$ South and longitudes $039^{\circ} 43' 35.0''$ East and $039^{\circ} 44' 37.7''$ East from Ras Iwetine in the southeast to Shanzu headland in the northeast of the beach (Fig. 2). The general trend of the Bamburi shoreline is about 030° to 210° from the magnetic north. Bamburi beach was selected because of the distinct spatial variations in beach erosion along the Bamburi shoreline. The beach morphological changes depicted exchange and transfer rates of sediment that affected the beach dynamics with apparent temporal and spatial alternate erosion and/or accretion on the beach (Fig. 3). The beach is characterized by coarse sand of

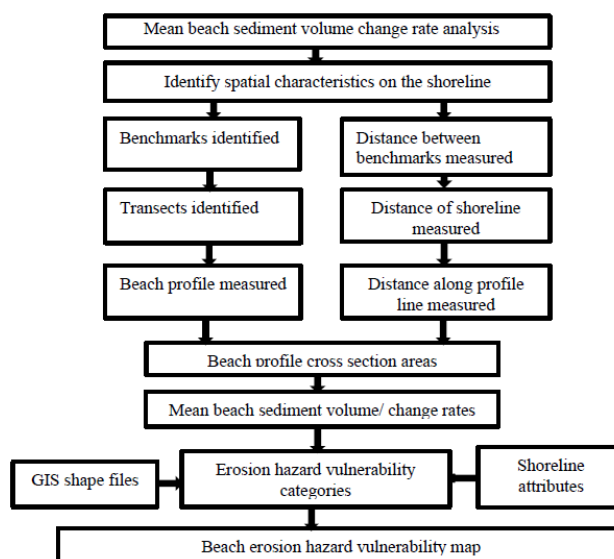
Fig. 5. Flow chart showing steps in beach erosion hazard vulnerability assessment.

respectively. Rate of change in the beach sediment volume was obtained by getting the range between the highest and the lowest beach sediment volume values. The range was then divided by the predetermined five relative erosion hazard vulnerability categories (Very high, High, Medium, Low and Very low). A positive reduced mean sediment volume change rate means that more sediment is carried away than is deposited and results in erosion of that spatial segment of the beach, while a negative reduced mean sediment volume change means that more sand deposition than erosion leading to accretion. Beach erosion hazard vulnerability map was generated to depict the hazard vulnerability for the whole beach length using the Environmental Systems Research Institute’s ArcView Geographic Information Systems (GIS) software with coastal features and other reference GIS layers generated from the East African Atlas of Coastal Resources for Kenya [26] of scale 1:250,000. The method is expressed in form of a flow chart as follows in Fig. 5.
