# Hydro-Geomorphologic Diagnosis of a Rainfall-Induced Landslide in Davao City, Philippines: Implications for Community Resilience

Lester G. Padilla\* and Eleonor V. Palconit

School of Engineering and Architecture, Ateneo de Davao University, Davao City, Philippines  
Email: lesterpadilla1993@gmail.com, lgpadilla@addu.edu.ph (L.G.P); evpalconit@addu.edu.ph (E.V.P)

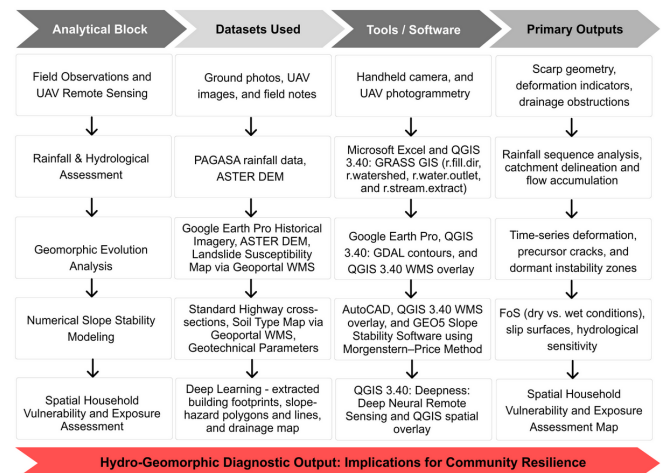
Fig. 2. Workflow of the hydro-geomorphic diagnostic assessment.

The overall methodological framework adopted in this study is summarized in Fig. 2. It integrates 5 primary analytical blocks and datasets, field observations with UAV remote sensing, rainfall and hydrological assessment, geomorphic evolution analysis, numerical slope stability modeling, and spatial household vulnerability and exposure assessment [17, 18]. Field evidence, multi-temporal satellite

imagery, Digital Elevation Models (DEMs), rainfall hyetographs, and soil strength parameters were processed to generate inputs for hydrological, geomorphic, and numerical stability analyses [19, 20]. These analyses were implemented using QGIS (for hydrological and terrain functions), GRASS GIS (for catchment and drainage delineation), and GEO5 Slope Stability (for Limit Equilibrium Method) [21, 22]. The workflow linked input datasets with diagnostic outputs, including factors of safety, hydrological response, and modeled slope failure geometries, which were subsequently validated against field observations. Collectively, the framework provides an integrated hydro-geomorphic diagnostic for interpreting rainfall-induced slope failures and assessing their implications for community safety and resilience.

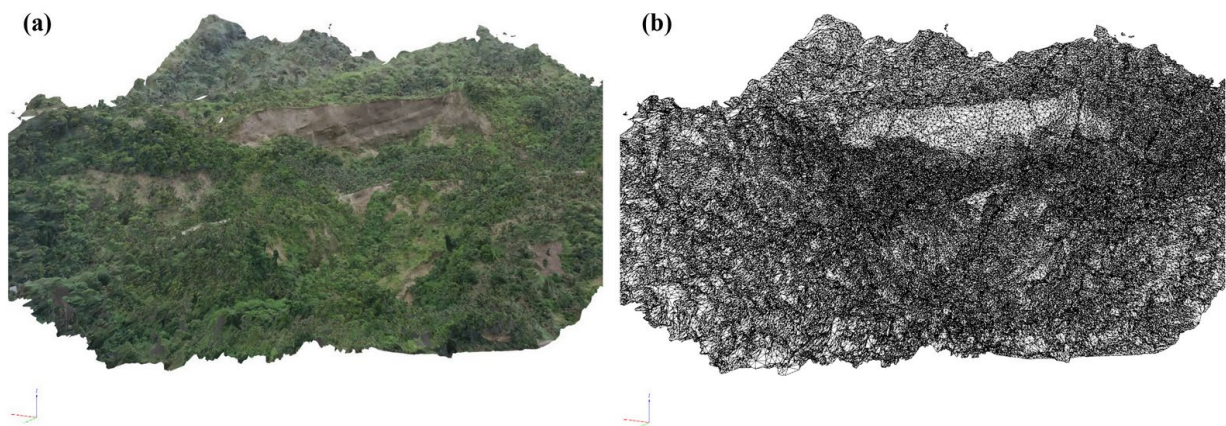
Fig. 5. UAV Photogrammetry (a) Textured 3D Model; (b) Triangular Surface Mesh.

A drone-based photogrammetric survey was conducted on August 29, 2025, as shown in Fig. 5, which generated both a textured 3D model (a) and a triangular surface mesh (b) of the Callawa–Fatima landslide [52]. The textured model clearly illustrated the sharp head scarp, displaced debris, and partial vegetation recovery, while also distinguishing bare surfaces that remain unstable. In contrast, the triangular surface mesh highlighted the geometric detail of the slope, delineating crown cracks, downslope bulging, and irregular terrain associated with mass displacement. Together, these outputs confirmed that instability persists more than three years after the failure, with adjacent steep sections showing limited ground cover and high susceptibility to secondary movement.

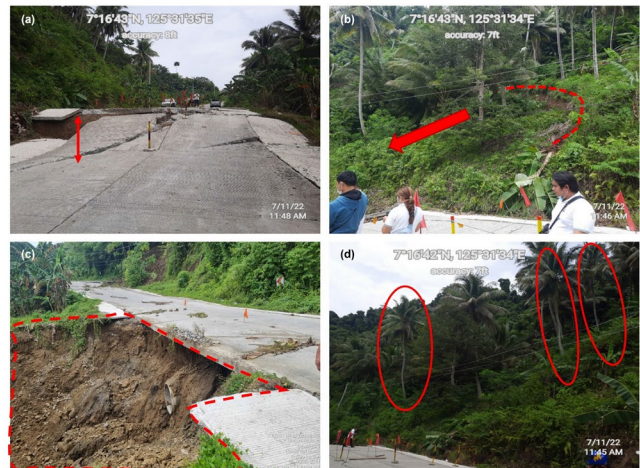
Fig. 4. Indicators of slope instability (a) roadway settlement & longitudinal cracks; (b) upslope tensile cracks; (c) downslope slip exposing cross-drain; (d) leaning trees (creep).

A site inspection on July 11, 2022, as documented in Fig. 4,

revealed visible signs of collapse. The roadway showed differential settlement (a), while tensile cracks traced the upper slope (b), marking the early stage of the main scarp. On the downslope side (c), a partial road slip exposed the cross-drain, which had already been damaged by ground movement. Vegetation stress was also evident, (d) with several leaning trees suggesting progressive displacement. Taken together, these observations confirmed that the slope was in a pre-failure state, with structural and geomorphic indicators pointing to imminent large-scale movement once additional rainfall occurred.

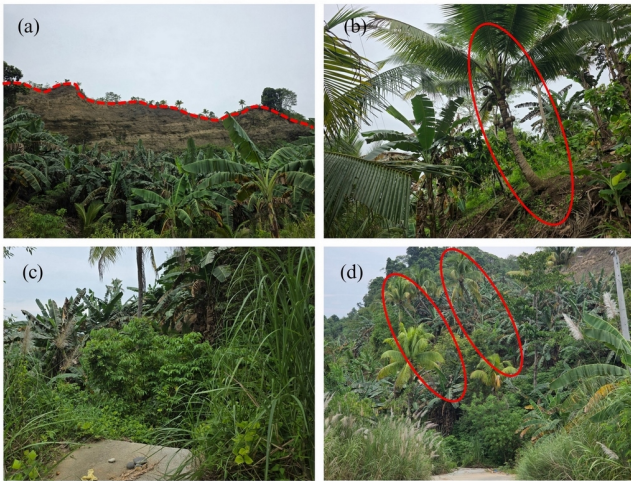
Fig. 6. Ongoing slope movement indicators (a) main scarp with banana regrowth, (b) leaning coconut with exposed roots, (c) displaced pavement at one end of the collapsed road, and (d) bent trees downslope.

conditions documented in Fig. 6. The main scarp was still prominent, with banana growth observed along the middle

section of the collapsed section (a). Signs of continued movement included a leaning coconut tree with exposed roots (b) and additional bent trees downslope of the scarp (d). At the end of the landslide road section (c), the pavement was displaced and partly buried by soil and dense vegetation, marking the termination of the failed alignment.

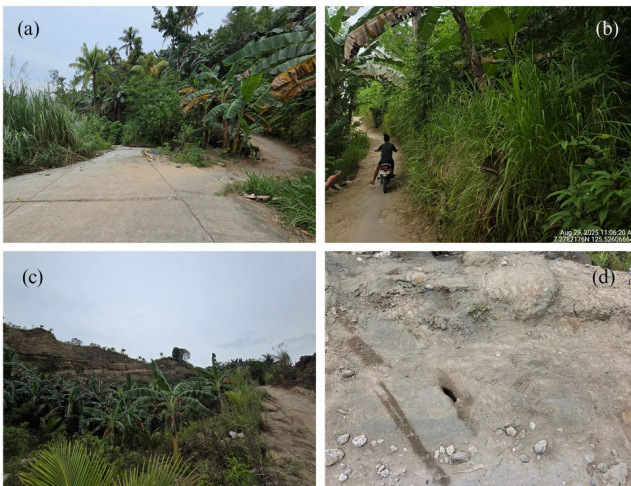
Fig. 7. Post-failure access and surface deformation (a) narrow improvised bypass at the failed section; (b) motorcycle crosses toward Barangay Fatima; (c) unpaved track with banana regrowth on the slide mass; (d) developing tensile crack along the path.

Additional ground evidence, as shown in Fig. 7, highlighted how the landslide site continues to impact mobility. At the start of the failed section (a), residents created a narrow detour that allowed only motorcycles to pass, cutting directly across the middle of the landslide zone just below the main scarp. A motorcycle passerby was observed using this route to reach Barangay Fatima (b), avoiding the longer alternate road. The detour remained unpaved, with banana growth visible in the middle of the landslide body (c). Lastly, a developing tensile crack was observed along this improvised pathway (d), indicating that the ground remained unstable even along the trail currently used by the community. These observations demonstrated the continued exposure of residents, who rely on this everyday passage despite the high risk of slope movement.
