# Environmental Impact of Leachate Pollution on Groundwater Supplies in Akure, Nigeria

**Abstract**— Physical, chemical and bacteriological analyses of water samples from three boreholes located near a landfill at Akure, Nigeria was carried out to ascertain the magnitude of dumpsite pollution on groundwater quality. Borehole locations were at radial distances of 50m, 80m, and 100m respectively away from the landfill. The parameters determined included; turbidity, temperature, pH, Dissolved oxygen (DO), total dissolved solids (TDS), Total Hardness, Total Iron, Nitrate, Nitrite, Chloride, Calcium and heavy metals such as Copper, Zinc and Lead using convectional equipment and standard laboratory procedures. Most of these parameters indicated traceable pollution but were below the World Health Organization (WHO) and the Nigerian Standard for Drinking water quality (NSDWQ) limits for consumption. The pH ranged from 5.7 to 6.8 indicating toxic pollution, turbidity values were between 1.6 and 6.6 NTU and temperature ranged from 26.5 to 27.50C. Concentrations of iron, nitrate, nitrite and calcium ranged from 0.9 to 1.4 mg L<sup>-1</sup>, 30 to 61 mg L<sup>-1</sup>, 0.7 to 0.9 mg L<sup>-1<

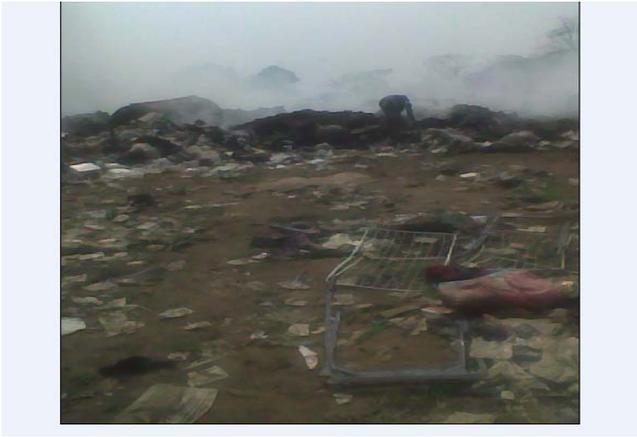
Figure 1: Picture of some portions of the dumpsite along Igbatoro road Akure, Nigeria

The study area (figure 1) was the dump site (Landfill) of Ondo state Waste Management Authority Yard situated along Igbatoro Road, Akure in Ondo State, located in South
